### Applicable To Underwing Refueling Nozzles

64200 Series

SB02092017  
February 9, 2017

## Cotter Pin dislodgement

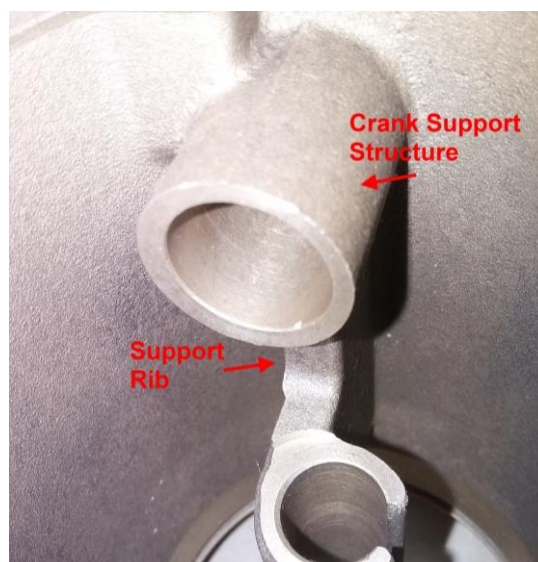
Figure 1 Nozzle Body

We were recently made aware of multiple crank pin failures at various sites due to inadvertent cotter pin dislodgement. Without a cotter pin to properly secure the crank pin and castle nut it is possible for the poppet linkage to become detached. This can lead to fuel spills when the nozzle is disconnected from the aircraft. We believe it is possible for the cotter pin to become dislodged if installed incorrectly. If the cotter pin is improperly installed it may contact the nozzle body during the process of rotating the crank handle. As the crank assembly rotates around the nozzle body housing it may bind against the crank support structure or the casted support rib (Figure 1). When this event is repeated it can fatigue the cotter pin and cause it to fail.

Due to the type of failure reported, and a potential for fuel spillage, we recommend inspecting nozzles currently in use. It is important to ensure the cotter pin is properly installed and secured so that it does not become inadvertently dislodged. If it is difficult to view the cotter pin from the inlet side you may open the nozzle poppet and view the cotter pin from the outlet end of the nozzle using a nozzle opening tool. It is important to ensure all pressure has been relieved prior to inspection.

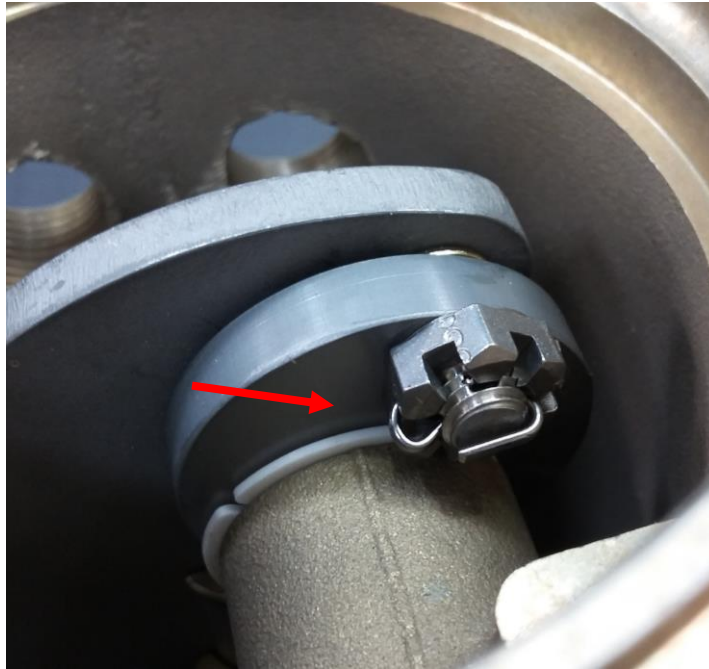
**Figure 2 Crank Assembly**

Ensure the cotter pin and castle nut are properly attached to the crank pin. The assembly should look like figure 2. If any of the items are damaged or missing the nozzle should be taken out of service and repaired.

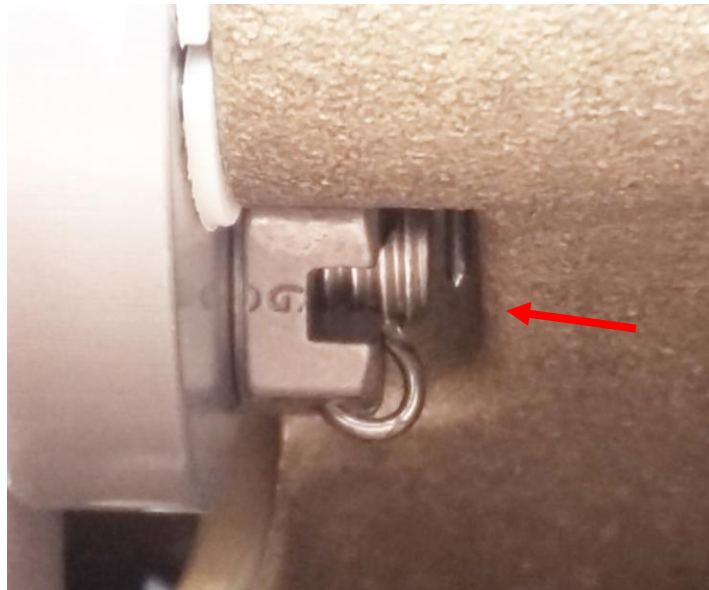
**Figure 3 Cotter Pin Clearing Support Rib**

Ensure the cotter pin does not contact the nozzle body or the support rib. A properly installed cotter pin should pass through the slot in the support rib with adequate clearance similar to figure 3.
